Drone-based 3D Model Reconstruction of Roadways: A Case Study

Keywords: Data Visualization, Path Planning, UAV, 3D Model, Asphalt Pavement, Aerial-based Inspections, Remotely Piloted Aircraft System (RPAS)

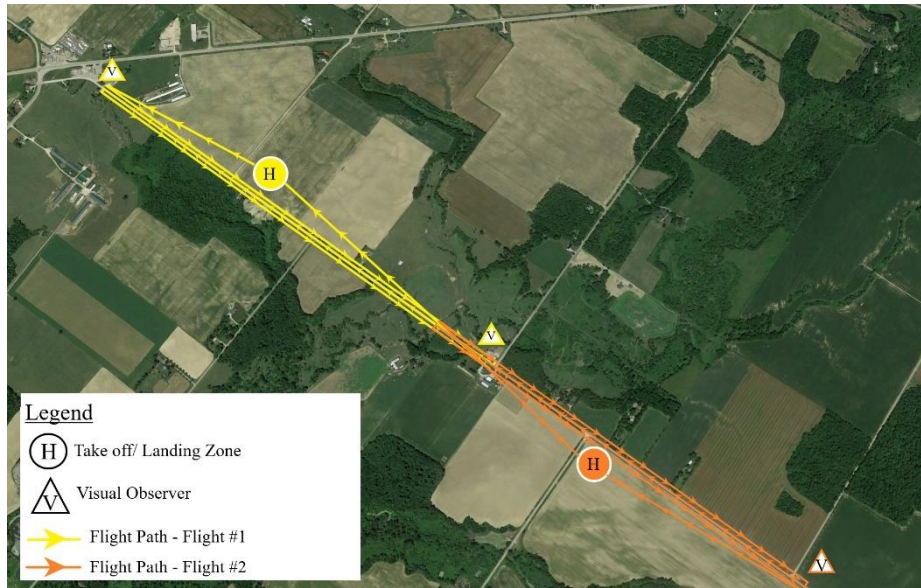
Fig. 4. Path planning for Amiens Rd UAV-based inspection.

A detailed map showing the flight path, take-off/landing areas, and flight area boundaries taken during the pavement condition assessment is depicted in Fig. 4. The approach taken during this study was Visual Line Of Sight (VLOS) (as required by SOR/96-433 901.11 [3]) drone-based data collection. This required our crew to launch and recover the drone multiple times to cover the extent of the inspection area. This

setup requires “visual observers” (SOR/96-433 901.20 [15]) positioned along the roadway (represented by triangular elements in Fig. 4.) to maintain visual contact with the drone throughout its flight, and to communicate details about the status of the operation to the pilot.

The inspection of Amiens Rd was segmented into two separate flights in order to maintain VLOS during the planned flights with the assistance of visual observers. The first flight (Flight #1) was planned between approximately 500 m east of Hickory Corners on Amiens Rd to 500 m east of the intersection of Ilderton Rd and Amiens Rd. The second flight (Flight #2) was planned between approximately 300 m west of the intersection of Ilderton Rd and Amiens Rd to 500 m east of Ivan Dr and Amiens Rd. The two flight paths overlapped by a distance of approximately 800 m to ensure enough data was available to integrate each flight in the post-processing stage and to achieve accurate and high-quality results for this boundary region. All path planning was conducted directly in the DJI Pilot 2 app available on the controller. The flight route altitude was selected as 125 ft AGL to achieve an average Ground Sampling Distance (GSD) (the ratio between the distance between two consecutive pixel centers and the real-world measurement on the ground) of 0.48 cm/pixel for both flights. A course angle of flight of 135° was chosen for both flights to ensure the flight path was parallel to the direction of Amiens Rd. This reduced the number of passes required by the drone to capture the full area of the study. Finally, the side and frontal overlap ratios were set to 70% and 80%, respectively, to ensure significant overlap of images recorded by the camera and to prevent the creation of gaps in the final 2D image orthomosaic, particularly at the edges of the images.

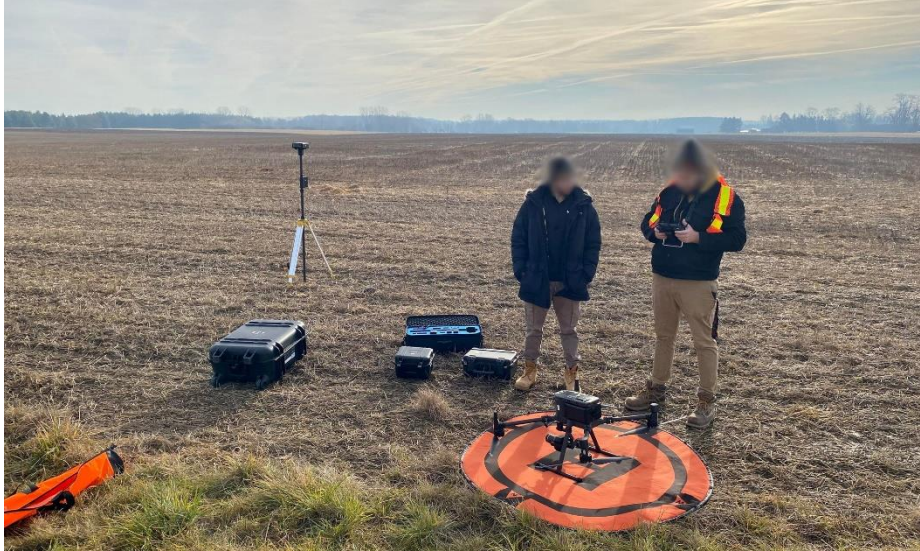
Fig. 5. Typical in-field setup of UAV devices and related equipment.

The D-RTK 2 High Precision GNSS mobile station, drone, camera, controller, and other equipment, including tripod and landing pad, were set up as demonstrated in Fig. 5. The KML flight path files created, as described in Section 3, were uploaded from the controller to the drone to allow for autonomous flight with minimal involvement from the pilot during the two planned flights. A pre-flight briefing was held to discuss the objectives of the flights, the normal operating procedures, emergency procedures, and the duties of the visual observers in accordance with SOR/96-433 901.20, 901.23, and 901.28 [3]. Each visual observer assumed their position, as shown in Fig. 4. before the flight commenced, and radio contact was established to ensure continuous communication between the pilot and the visual observers. During both flights, the D-RTK 2 High Precision GNSS mobile station provided GNSS corrections to resolve time and atmospheric ambiguities with the centimeter-level positioning data of the camera recorded at the time that images were captured. A connection, with an average of 26 satellites, was maintained by the D-RTK 2 High Precision GNSS mobile station to record the GNSS fixed position of each aerial photo throughout both flights. No ground targets or survey benchmarks were measured prior to data acquisition. Based on the chosen area of inspection, as well as the side and frontal overlap ratios and chosen GSD value, a total of 2266 RGB images 8192px in length by 5460px in height with a resolution of 44.73 Megapixels (MP) were captured during both flights. Table 1 summarizes other details regarding each flight; including total travel distance, total inspection area and length, average horizontal speed, flight duration, and the number of images captured during each flight. Once the flights were completed, documentation of the flight including participants, collected data, timing of flights, and the location and duration of the flights was recorded as per SOR/96-433 901.48.
